# Manhole Inspection Summary

Manhole # S35II\_054MH

Insp Date: **3/14/07 10:46 AM**

**Location** Address: **1718 BARCLAY ST**

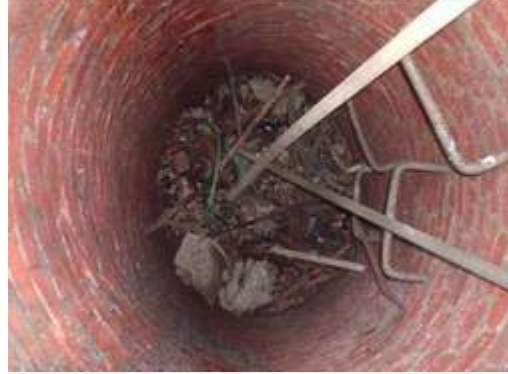
Top View

Channel debris.

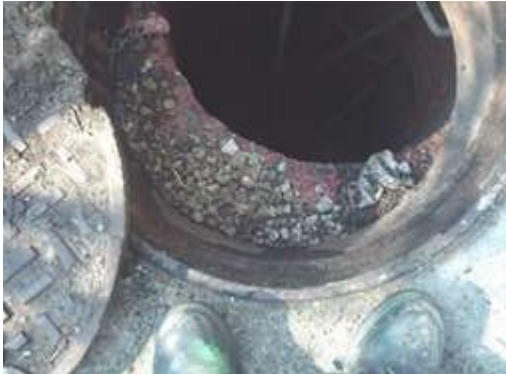
Defect

Frame leaks. Frame offset.

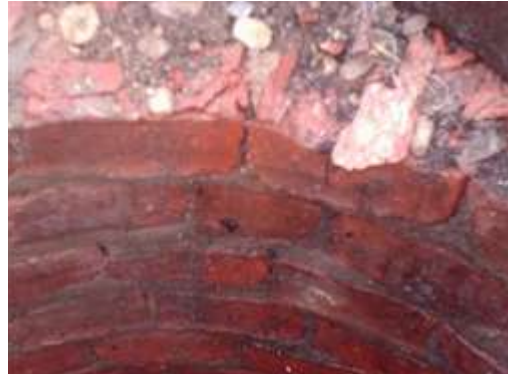
Defect

Corbel deterioration and infiltration.

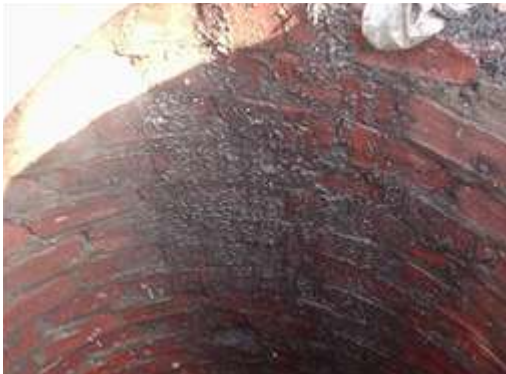
Defect

Corbel infiltration.

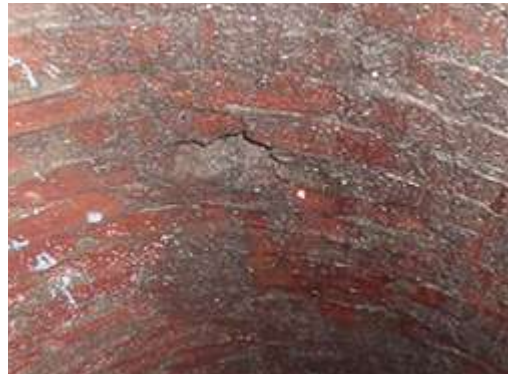
Defect

Barrel deterioration and infiltration.

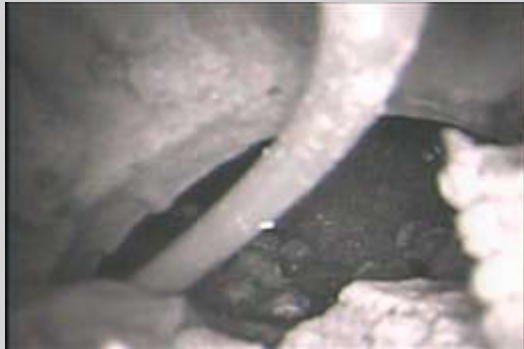
8 in. Circular Gravity Sewer  
Pipe Out @ 12 O'Clock

Deposits: ☐ None ☒ **Mud** ☐ Sludge ☒ **Debris** ☐ Grease

Silt Depth: **7** (in.) Deposits Extent: **Heavy**
